Worldwide repairs carried out with PolymerMetal®

REP-# 040

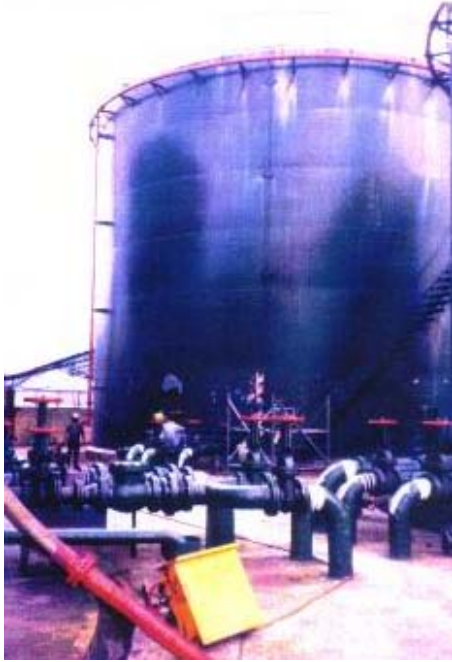
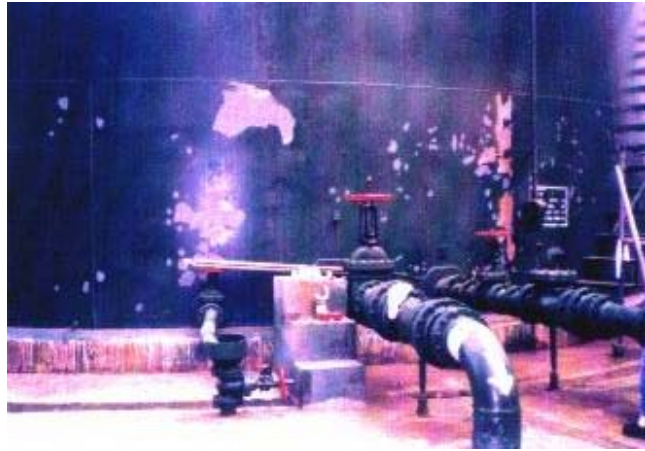
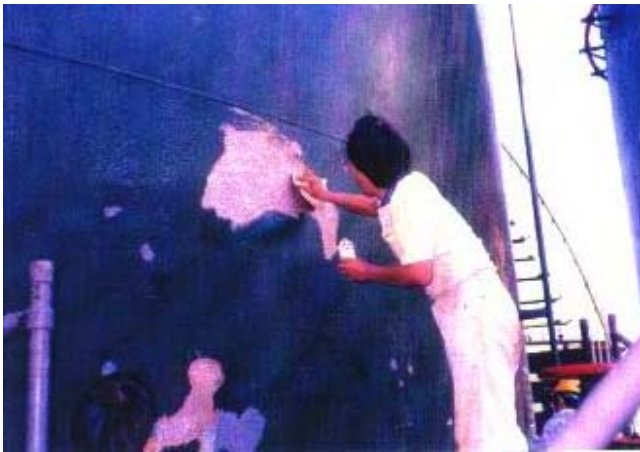
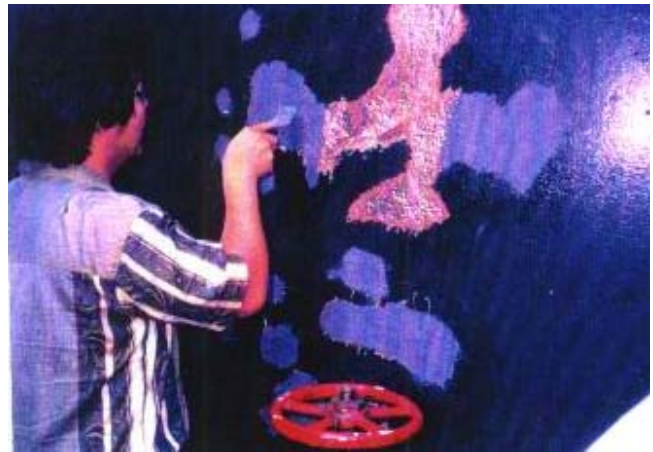
During the maintenance on a fuel/oil storage tank several leakages were noticed. After sandblasting the leakages were sealed by using the direct-MM-bonding method with MM-metal oL-steelceramic and Hardener red. Furthermore parts affected by pitting were coated by applying MM-metal SS-steel, pasty. 24 hours were needed for the repair works with PolymerMetals, curing time included. The usual repair procedure including emptying of the tanks, cleaning of steel walls and welding would have taken 6 days.
